worn-out-half-nuts-all

Part of my machining hobby is restoring worn machinery to usable condition and getting those machines in the hands of people who want to make chips. A recent reconstruction of a South Bend Model A involved restoring completely worn out (as in completely gone) half nut threads.

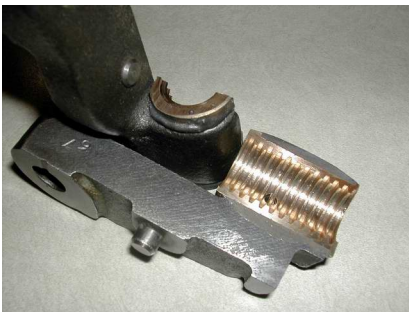
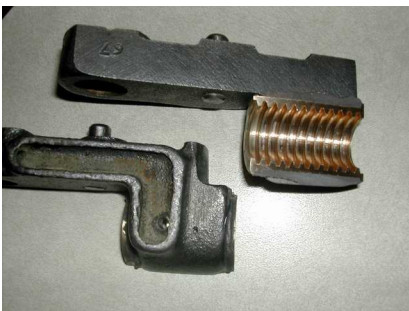
I cannot figure how these half nuts were worn out so badly on a Model A, but there was no disputing what they were. I bored out old threads to a .900" bore. Made a bearing bronze spool to .895" to allow for epoxy to fill gap and account for misalignment. Then I single pointed the threads till spool threaded on leadscrew easily. I then made a few passes on the spool outside diameter at 4tpi to rough-up for epoxy to grip. I then installed the bored half-nuts in the apron, put the apron back on lathe, screwed the spool onto leadscrew, replaced lead screw end support to line things up, then clanked half nuts closed on spool to test fit.

Once it looked like it would work, I coated spool with epoxy, clanked half nuts closed, then let cure for a few days. I then removed the apron by running lathe screw backwards. I then drilled and pinned (1/16") on each end of spool lip. I then clamped the half-nut assembly in the mill vise and split it with a big slotting saw, drilled oil holes, and Voila. half nuts live again.
